EXHIBIT 12

Degradation of polypropylene in vivo: A microscopic analysis of meshes explanted from patients

Vladimir V. lakovlev, 1 Scott A. Guelcher, 2 Robert Bendavid3

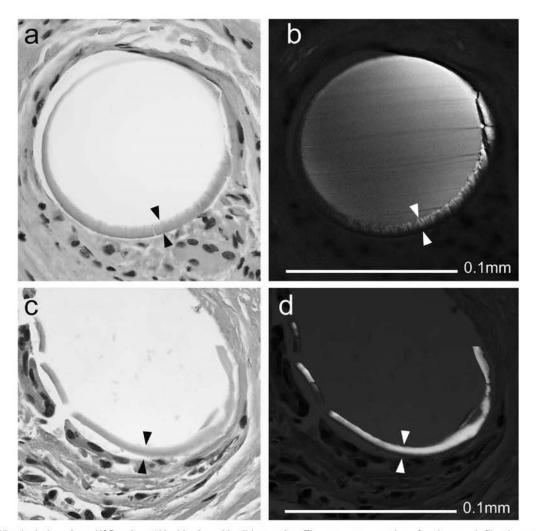
FIGURE 2. Histological sections, H&E stain, ×100 objective with oil immersion. The same cross section of a clear mesh fiber in regular (a) and polarized (b) light. The fiber has a layer of staining degraded polypropylene at the surface (between arrowheads). This layer has refractile properties of polypropylene in polarized light (b). In some areas the non-degraded core of the fibers detaches during histological processing while segments of the degraded layer stay attached to the tissue. Separated degradation layer in regular (c) and polarized (d) light. At sites like this, intensity of light passing through the degraded layer cannot be attributed to light scatter from the core. Note that tissue components including collagen have a much weaker birefringence than polypropylene (b and d). [Color figure can be viewed in the online issue, which is available at wileyonlinelibrary.com.]

polypropylene. In polarized light, both the central core of the fibers and the outer layer showed similar refractile properties [Figure 2(b)]. The light intensity was uniform within the core while the outer layer had gradual reduction of the refractile ability toward the surface. Birefringence of the outer layer was also observed in the segments of the "bark" separated from the core [Figure 2(c,d)]. At these sites, the light brightness in the "bark" layer was due to its internal properties and could not be attributed to the scatter of light from the core. The adjacent tissue components containing collagen also showed birefringence, however of a much lower intensity. The tissue components also had a different structure and coloration

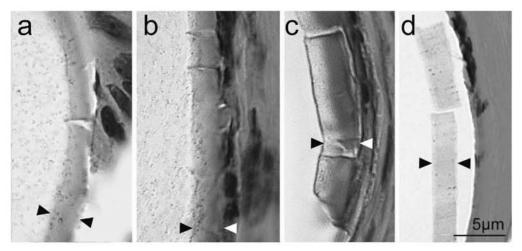
FIGURE 3. Degradation "bark" of the blue fibers manufactured with inclusion of blue dye granules, H&E stain, ×100 objective with oil immersion: (a) and (b) non-degraded core (left half of the images) and the degraded layer (between arrowheads). Note that the blue granules are retained in the layer of degraded polypropylene. Within the degraded "bark," the granules degrade and loose color toward the surface. In (c) and (d) the non-degraded core detached from the slides similarly to Figure 2(c,d). At these sites, presence of the granules in the separated "bark" cannot be attributed to an overlap with the core. [Color figure can be viewed in the online issue, which is available at wileyonlinelibrary. com.]

into the material during its manufacture (Figure 3). The granules were seen in the non-degraded core of the fibers as well as to a variable degree in the outer degradation layer. In the latter, they were detected within the "bark" remaining on the core [Figure 3(a,b)] as well as in the segments of the "bark" separated from the core [Figure 3(c,d)]. The granules were mainly seen in the deeper layers of the "bark" and were not as frequent closer to the surface, which suggests that they also undergo degradation and lose color. The finding was a direct confirmation that the "bark" originated from the same material as the core of the fibers.

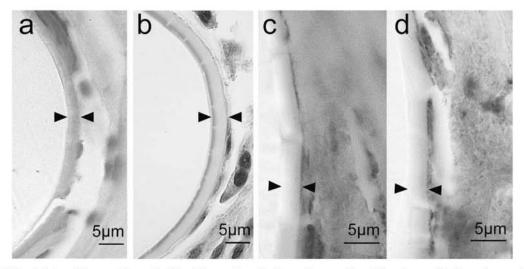
The brittleness, staining and birefringence characteristics of the "bark" were similar to those of calcium salts which are commonly deposited in degenerating tissues. Von Kossa stain was used for a sample set of 10 specimens to rule out presence of calcium salts in the outer "bark." No calcium salts were detected in the brittle outer layer of the 10 specimens tested [Figure 4(a)].

FIGURE 4. Additional stains, all images taken with 100x oil immersion objective and cropped to a different magnification, polypropylene degradation layer is pointed between arrowheads: (a) Von Kossa stain is negative for calcium in the brittle "bark" (would stain calcium black), (b) trichrome stain shows that the deeper parts of the "bark" have smaller staining porosity (red) than those close to the surface (green) which correlates with TEM findings [Figure 6(b)], (c) immunohistochemical stain for immunoglobulin G (IgG, stained brown). IgG is present in almost all human tissues and fluids. It is deposited on the surface of degraded polypropylene but is not mixed within it. (d) Immunostain for the oxidizing enzyme of inflammatory cells myeloperoxidase (stains brown). [Color figure can be viewed in the online issue, which is available at wileyonlinelibrary.com.]

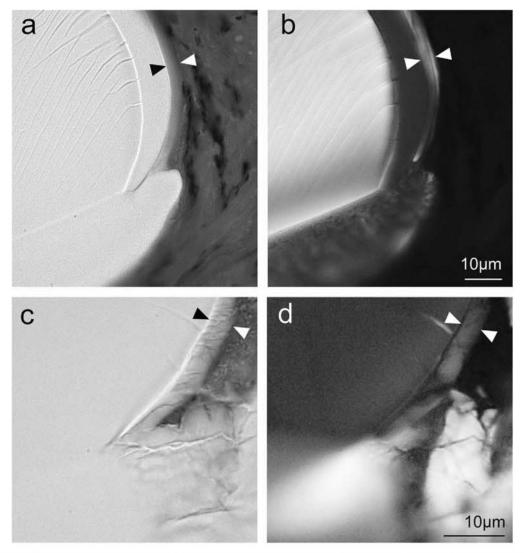
Surgical cautery instruments cause heating of the tissues to a wide range of temperatures. There is usually a narrow zone of high temperature immediately at the tip of the instruments with a sharp drop in temperature in the deeper tissue further away. In excised specimens cautery changes (darkening and nuclear streaming) are seen within 1-2 mm from the cauterized surface. In these areas, mesh fibers showed sites where both the outer degraded polypropylene "bark" phase and the inner non-degraded polypropylene phase melted and mixed to form a single homogeneous phase (Figure 5). The phase-mixed regions did not absorb histological dyes, thereby showing that they lack porosity observed in the degraded polypropylene. The fact that the "bark" was melted during excision surgery indicated that the degradation layer was formed in the body before the excision surgery. The finding also revealed that the fiber core and the outer "bark" are composed of materials with similar chemical compositions that are miscible with each other when heated.

FIGURE 5. Melting of both non-degraded and degraded polypropylene caused by the surgical cautery, H&E, ×100 oil immersion: (a) and (b) the same site of fiber melting in regular and polarized light, (c) and (d) another site showing melding point. While molten the non-degraded core and the degradation "bark" formed a common pool of material. [Color figure can be viewed in the online issue, which is available at wileyonlinelibrary.com.]

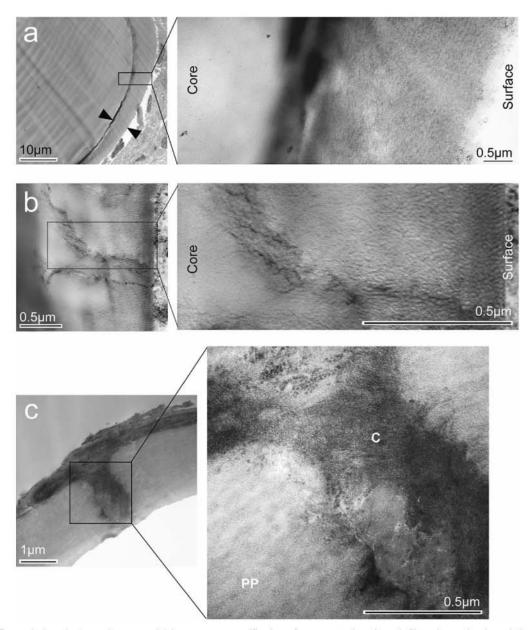
We used TEM to study the ultrastructural organisation of the degraded layer in cross sections. The mesh fibers showed an outer "bark" similar to that seen by light microscopy [Figure 6(a)]. There were no fibrillary (collagen, amyloid etc.) or other structures of connective tissue matrix within the "bark". Material composition of the outer layer and the core showed similar electron density; however, at high magnification the outer "bark" was noticeably more granular, especially toward the surface [Figure 6(a), insert].

The "bark" material had a lattice of fine branching cracks (nanocracks). This network of nanocracks was sparse closer to the core and expanded toward the surface [Figure 6(b)]. As seen in Figure 6(b) in addition to the nanocracks there were also occasional larger cracks occurring at random. These larger cracks seen by TEM corresponded to the cracks seen by light microscopy either on the surface (Figure 1) or in cross sections (Figure 2).

The "bark" either had a gradual transition into the core [Figure 6(b)] or showed a zone of circumferential fissuring partially separating it from the core [Figure 6(a)]. The mechanisms of "bark" separation from the core and formation of the larger cracks are likely linked since the cracks tended to turn at the interface between the "bark" and the core [Figure 6(b)]. The forces which produced the transverse (radial) cracks also acted as shear forces between the "bark" and the core.

An important finding was the detection of inflammatory cells partially migrated into and trapped within the fissures as shown in Figure 6(c). The shape of widened crevices and the depth of penetration indicated an active *in vivo* cellular migration. This phenomenon was observed at two separate sites.

FIGURE 6. Transmission electron microscopy. (a) Low power magnification of a cross-sectioned mesh fiber shows the degradation layer similarly to light microscopy, the insert shows an image composed of three high power fields to reconstruct the transition between the non-degraded core and the degradation "bark." Note the fine nanocracks/nanopores in the degraded material. (b) Outer part of the fiber with gradual transition between the non-degraded core and the degraded polypropylene at the surface. The lattice of nanocracks expands toward the surface (left to right). There are also two larger cracks which start perpendicular to the surface but then turn at the interface between the core and the degraded layer. (c) A part of inflammatory cell (labeled C in insert) is trapped in a fissure within the degraded polypropylene (PP). Higher magnification (insert) shows cellular membrane at the cell-polypropylene interface (left wall of the fissure) and cellular organelles in the cell (chains of rounded structures, likely ribosomes).

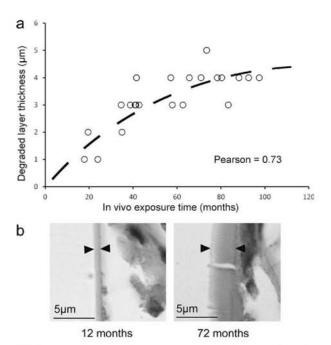
Out of all the specimens, 23 samples of explanted midure-thral slings formed the largest group of meshes from the same manufacturer, of identical mesh type and with reliable records of implantation and excision dates. The range of in vivo interval (between implantation to excision) in the group was 18-97 months (mean 53). There was a good correlation (Pearson = 0.73) between the thickness of the degradation layer and the duration of in vivo exposure indicating that the thickness of degraded material grows while the mesh is in the body [Figure 8(a,b)]. There was a trend for a more rapid initial growth with gradual plateau subsequently.

FIGURE 8. Duration of *in vivo* exposure versus thickness of degraded layer in a group of explants of the same manufacturer and the same mesh design. (a) Thickness of the degradation "bark" increased over the years *in vivo* (Pearson correlation = 0.73). Note the trend of plateauing after 5–6 years. There was no correlation of the thickness with the duration of specimen storage in formalin (not shown, Pearson = -0.06). (b) Comparison of the "bark" in meshes explanted after 12 and 72 months in the body, H&E, $\times 100$ objective with oil immersion, images cropped to the same magnification factor. [Color figure can be viewed in the online issue, which is available at wileyonlinelibrary.com.]
